**AHERA PERIODIC SURVEILLANCE FORM
Management Plan Document**

Building Name: Hillsboro Elementary School
37110 Charles Town Pike, Purcellville, Virginia
Bulletin Board +

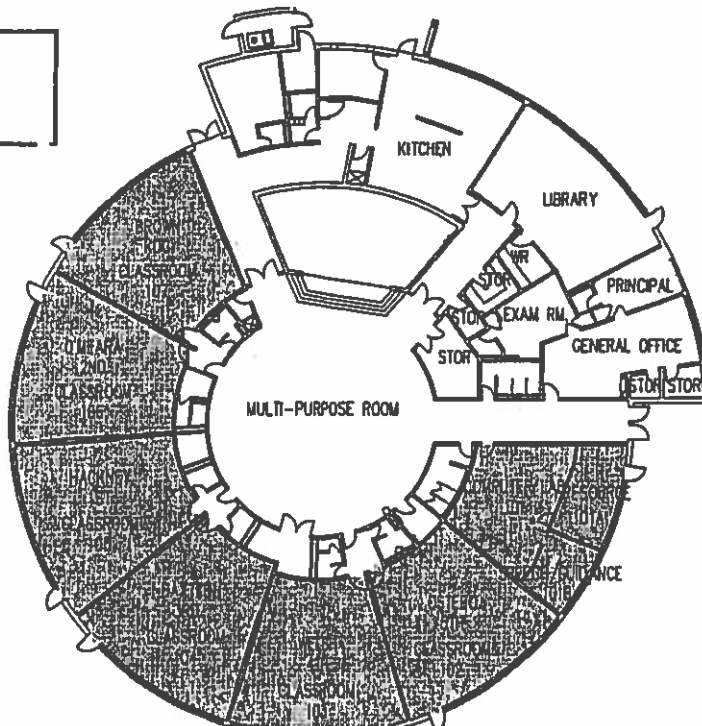
FRNK/HELVESTON
COTTAGE #1
ART/MUSIC

Type of ACBM/Location: Chalkboard mastic (assumed asbestos-containing):

- Assumed behind all chalkboards throughout building

1. Physical Damage (Yes or No)
2. Water Damage (Yes or No)
3. Delamination (Yes or No)
4. Located in Air Plenum (Yes or No)
5. Other: *Inaccessible*

Many appear nailed or screwed in but mastic may be supplemented.

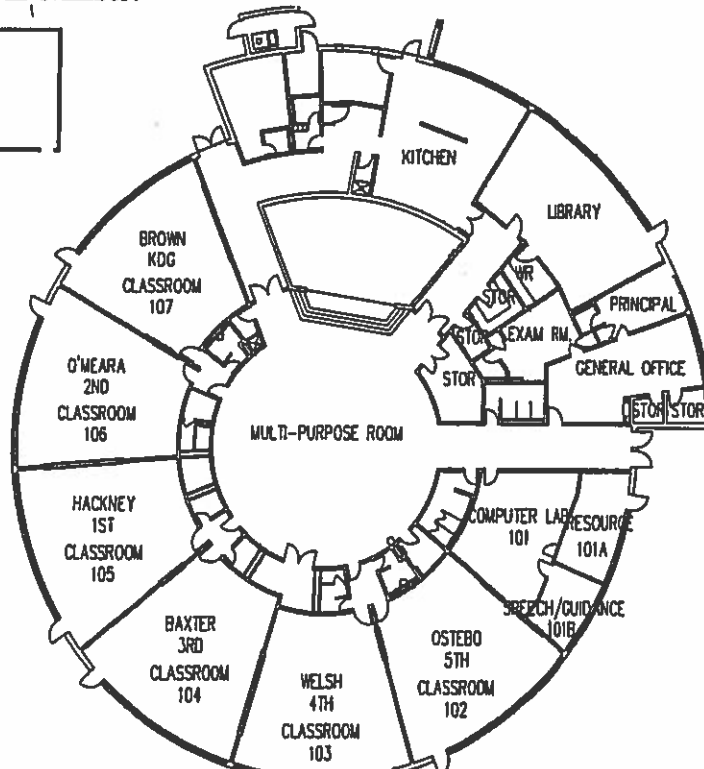
FINK/HELVESTON
COTTAGE #1
ART/MUSIC

Type of ACBM/Location: Pipe Insulation

- Assumed behind plaster walls, ceilings, and inside pipe chases

1. Physical Damage (Yes or No)
2. Water Damage (Yes or No)
3. Delamination (Yes or No)
4. Located in Air Plenum (Yes or No)
- ⑤ 5. Other: *Inaccessible*

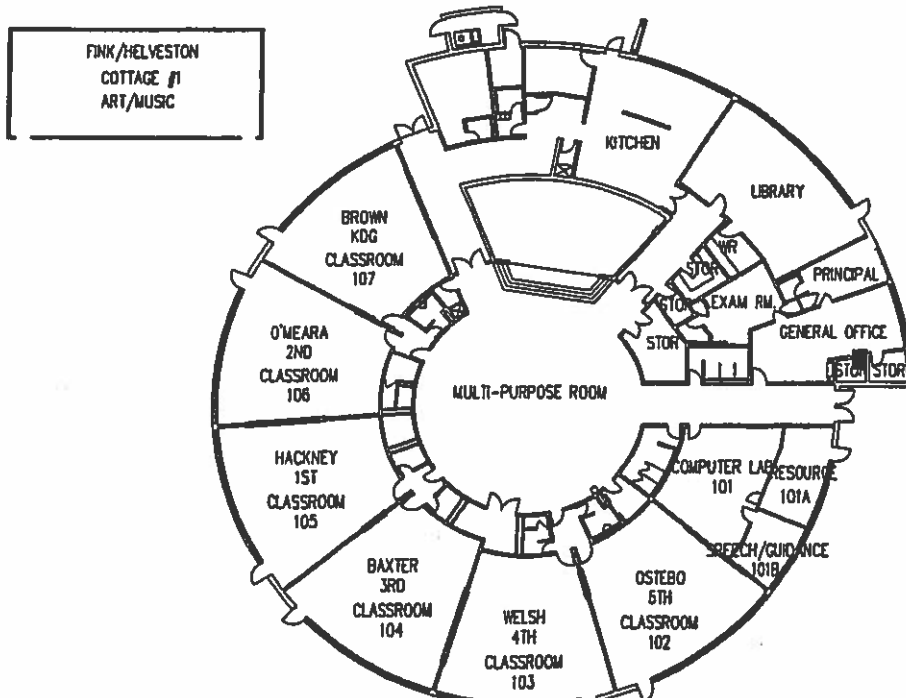
Homogenous Area ID Number: (F.2) M04

Type of ACBM/Location: Fire door (assumed asbestos-containing):

- Main office storage room
